Excavator Operator Best Practice

TO EXTEND BUCKET LIFE ON MINE SITES

FREE WHITEPAPER

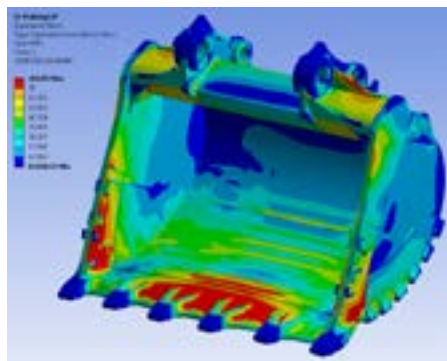
Stress analysis showing the effect of 'walking' a bucket on the bucket's lip.

The main offender in the creation of bucket issues is walking (repositioning) of the excavating machine via the bucket. This deviation from standard digging practices causes slew ring issues and boom and stick cracking.

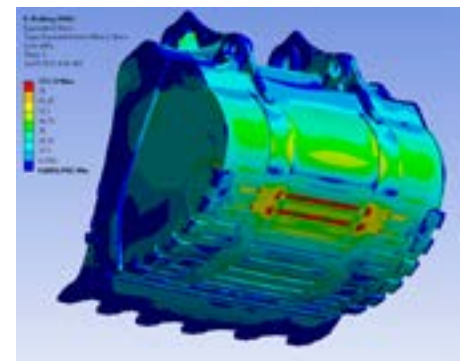
Stress analysis showing the effect of 'walking' a bucket on the bucket's shell.

Misuse of a bucket in this way will typically result in a portfolio of common problems such as the following. Actions which cause compression of the top box connection areas cause cracking and fatigue. Load on the bucket causing bulging of the side walls causes cracking and wear plates to crack from the bucket's sides. Point loading to the floor can eject the wear package and buckle or twist floor plates and side scraping with the bucket can cause it to twist.

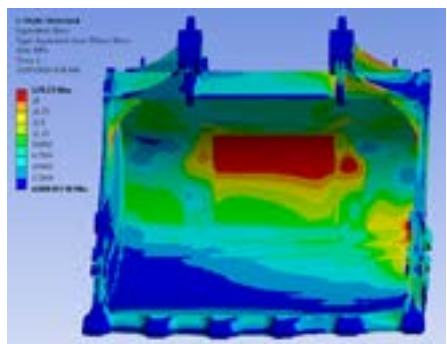
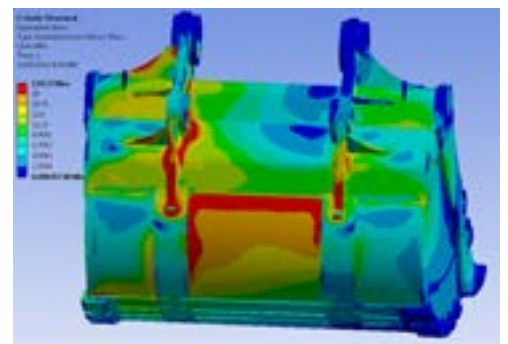
Stress analysis showing the effect of 'side-sweeping' with a bucket.
