# Case Study

## PIT WALL ROCK REMOVER

**INTERNATIONAL  
GOLD MINER**

**2007**

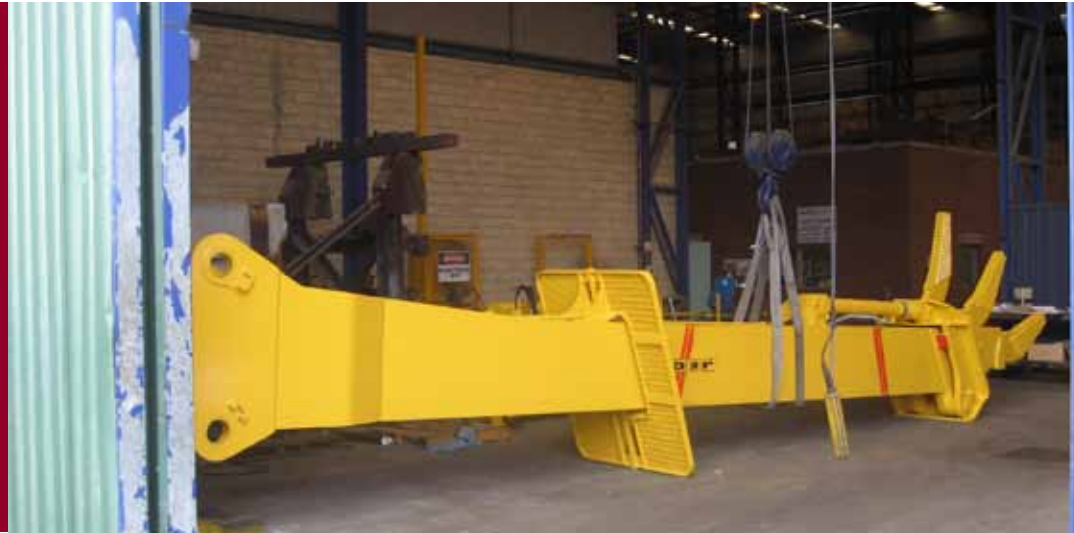
Using Pro-E 3D and FEA software, Austin Engineering completed a design proposal that would extend the boom by approximately 10 meters. It also included “claws” at the end of the boom that could be hydraulically operated from the cab to selectively pick rock from the high wall face.
